Analysis of Life-Saving Facilities System and Fire Management Facilities at Ogan Ilir Police Station in 2020

Vira Nalia Maharani¹, Novrikasari², Desheila Andarini³, Anita Camelia⁴, Poppy Fujianti⁵

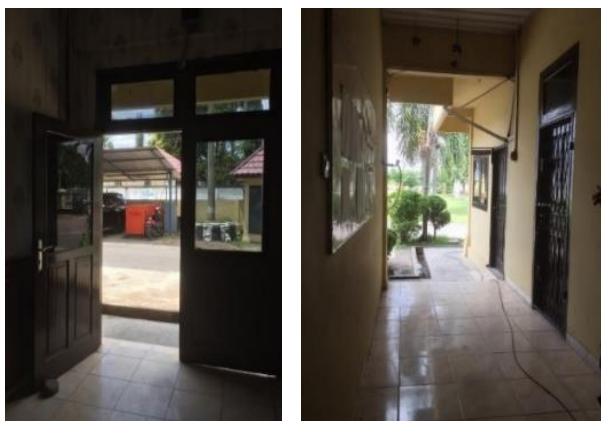
The main exit facility in Ogan Ilir Police Station is only an access door in the Main Building of Ogan Ilir Police Station as a place for officers to enter and exit. There are 3 main entrances to exit in the form of corridor. The entrances are also directly

Figure 1. Main Door Corridor for Exit Facilities at Ogan Ilir Police Station

connected to the road. In addition, the time it takes for officers and guests to reach the gathering place from the work area is ±2 minutes because the main building is right behind the gathering place.

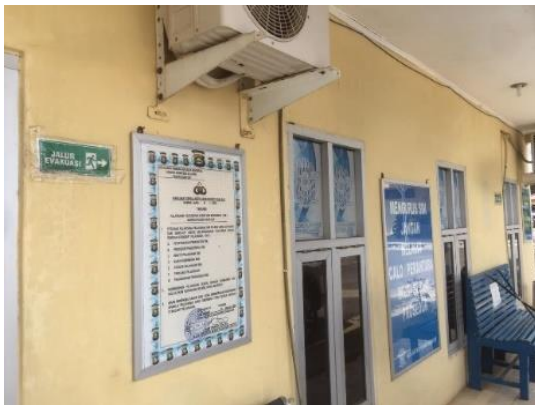
Based on the results of the research, the directions of the exit in Ogan Ilir Police Station are located in almost all work units and along the evacuation route. These exit directions will end at the assembly point in front of the public office. The exit directions in Ogan Ilir Police Station are rectangular in green color and have the words "EVACUATION

Figure 2. Directions of the Exit at Ogan Ilir Police Station

Based on the results of the comparison, it is known that Ogan Ilir Police Station already has signs for evacuation directions from the 8 elements set by the Regulation of the Minister of Public Works No. 26/PRT/M/ 2008, which was then carried out in accordance with the results of field observations. Furthermore, regarding the suitability of the signs for the evacuation direction of Ogan Ilir Police Station, 6 elements have fulfilled the requirements of the Regulation of the Minister of Public Works No. 26/PRT/M/ 2008, but there are 2 elements that have not been fulfilled, as every evacuation direction has not been continuously illuminated and the area inside the room and outside the room has not been illuminated.

Regarding whether each sign is illuminated continuously, from the results of the study it is known that all evacuation signs are not illuminated. This is in line with Mahmasshony's research suggesting that directional signs must be illuminated to make it easier for building occupants to read them, especially when it is dark (Mahmasshony, 2016).

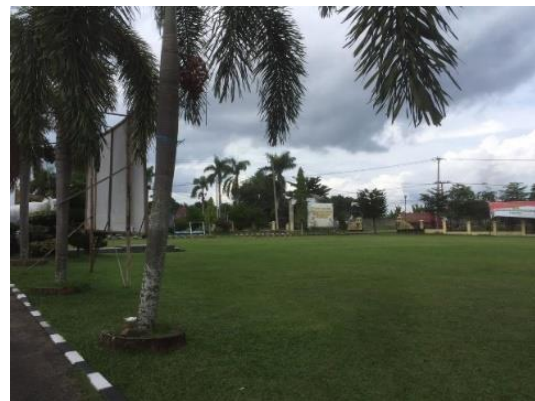
The assembly place in Ogan Ilir Police Station is claimed to be spacious to accommodate officers and guests in case of fire that requires evacuation. There are two assembly places for officers and guests in Ogan Ilir Police Station. The following is a checklist of the assembly place suitability for police officers and guests of Ogan Ilir Police Station with NFPA 101.

Figure 3. An Assembly Place of Ogan Ilir Police Station

Based on the results of interviews with key informants, the assembly place is in an open and wide ceremony field, but the marking of the meeting place has not been installed. If an emergency occurs for all members, guests are immediately directed to the meeting place in front of the main building, namely the ceremony field.

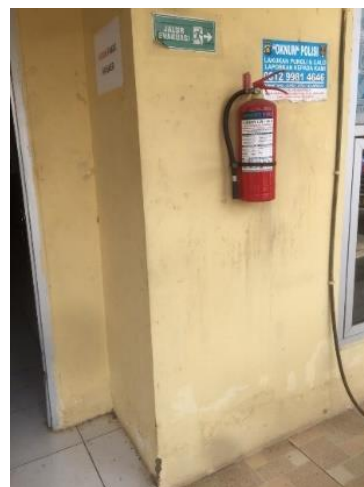
Based on the results of the interview, observations and secondary data, the total number of fire extinguishers is 10 APAR tubes. All APAR construction in Ogan Ilir Police Station is of the Stored Pressure Type with a weight of 6 kg with a type of fire extinguisher that is dry powder made from dry chemical flour. The placement of fire extinguishers in Ogan Ilir Police Station is placed 100 to 125 cm from the bottom of the floor. The maintenance and feasibility testing is conducted routinely once a year by the logistics unit.

Figure 4. A Fire Extinguisher at Ogan Ilir Police Station

Based on observations and interviews about fire extinguishers at Ogan Ilir Police Station in relation to the Regulation of the Minister of Public Works of the Republic of Indonesia No. 26/PRT/M/2008, there are 4 aspects that do not meet the requirements due to lack of knowledge of the checklist concerning APAR. APAR in Ogan Ilir Police Station does have labels affixed to provide information on manufacture's name or agent name, mailing address and phone number. According to the Regulation of the Minister of Public Works RI No. 26/PRT/M/2008, labels should be affixed as a means in case of damage, so that agent can be quickly and easily contacted (Regulation of the Minister of Public Works, 2008).
