Fire Protection Systems, Life-Saving Facilities, and Fire Management in Depok City in 2020: A Case Study

Cite this as: Andanar, M. W. and Erwandi, D. (2024) 'Fire Protection Systems, Life-Saving Facilities, and Fire Management in Depok City in 2020: A Case Study', *The Indonesian Journal of Occupational Safety and Health*, 13(3), pp. 304-313

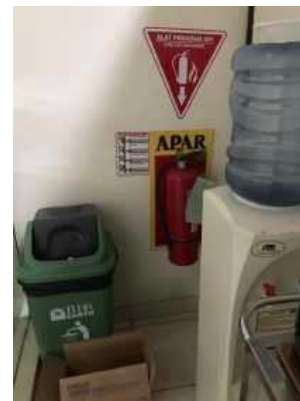
Figure 1. Fire Extinguisher Blocked by Objects

extinguishers in Hospital but only five elements of the standards are met. Fire extinguishers must be marked with color labels to indicate their type (Ministry of Health of the Republic of Indonesia, 2012); however, the fire extinguishers in Hospital X do not have labels. The fire extinguishers are not ready for use as some have not undergone monthly inspections, and their pressure levels fail to meet the required standards. Sari and Lestari (2024) stated that fire extinguishers must be checked routinely and refilled periodically even if they are not in use. Furthermore, several fire extinguishers in Hospital X were found to not have placement markings and usage instructions, and there were fire extinguishers that were not attached to hangers. Placing the fire extinguishers on a hanger is necessary to protect them and prevent them from being easily damaged, as well as for visibility reasons. Some fire extinguishers were found to be blocked by furniture, which could make them difficult to be found and accessed. The distance between fire extinguishers should be 15 meters, but in Hospital X, fire extinguishers were found with a distance of 24 meters. The condition of fire extinguishers that do not comply with standards will affect the ability, convenience, and readiness of the fire extinguishers in preventing fires to become larger and thus causing major fires (Yuniati and Wahyuningsih, 2022).

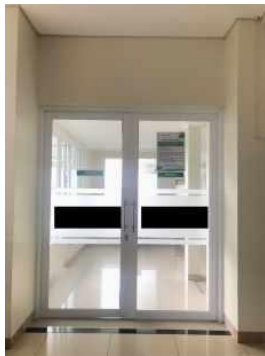
Figure 2. Gate of Bridge between Building A and B

Hospital X has three elements of the compartment that do not meet the standards and two elements that do. To prevent the spread of smoke and fire, there should be no gap between compartments. The larger the gap between compartments is, the swifter the smoke and fire to spread (Xin *et al.*, 2021). In addition, the compartments should be made of fire-resistant materials. Hospital X has compartments made of fire-resistant walls and doors, but several compartments have a gap that could cause fire to spread to the inside or outside. The compartment doors lack automatic closing mechanisms, meaning they do not close on their own when not in use. The doors on the bridge connecting Building A and Building B uses non-fireproof glass. This means that if a fire occurs in one of the buildings, the fire can spread to other buildings. In general, room doors in Hospital X are made of wood which cannot withstand fire.

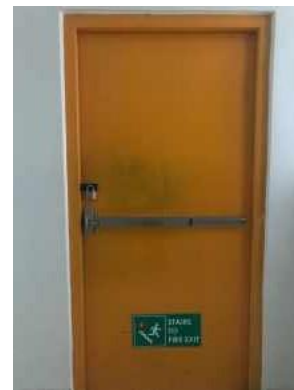
Figure 3. Emergency Door

Hospital X has six emergency doors but four of them do not meet the standards. Hospital X only has emergency doors in building B. On the fifth floor, the emergency door was found to be locked. According to the team of Hospital X, the emergency door is damaged and thus locked for security reasons. Additionally, the emergency door on the first floor is improperly installed, preventing it from being opened from the emergency stairs. In the event of a fire, this could trap residents in the emergency stairs, delaying evacuation. Furthermore, the emergency door does not lead directly to the outside but to a technical corridor. Ideally, an emergency door should connect directly to the outside area of the building to provide a clear escape route if other exits are blocked by fire or smoke. Additionally, emergency doors should open outward but not from the outside to prevent unauthorized entry (Irmawati, Suryani and Rakhmatsyah, 2020).
