Risk Factors Identification of Fire Incidents in 2017-2018

Putra Agata Lesmana

PT Indonesia Morowali Industrial Park

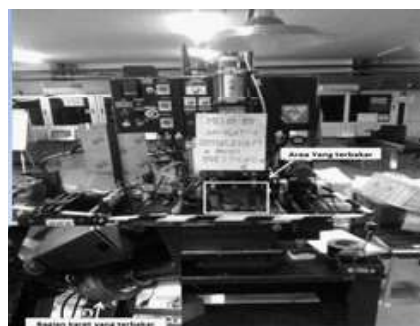
on 10 February 2017 during the shift change (shift 1 to shift 2) at 13:30 WIB. As affirmed by one of the respondents who work as a supervisor in the area, the fire came from the stamping process when the machine operator operated the product 4008 with the temperature parameter of 340° Celsius. After 30 of operation, the rubber dais was stuck and could not spin.

Due to the heat from the heater that reached 300° Celsius with the machine stopped, the fire arose from the rubber dais and quickly burned the KKS 6 machine. By referring to the respondent, the stuck engine might be caused by the dry bearing. The condition of the machine after the fire can be seen in Figure 1.

Figure 1. The KKS 6 Machine after the Fire in the Assembly Decoration 1 (AD1) Area

The first incident that happened in the KKS 6 machine was caused by the negligence of human resources or also known as unsafe action. The company has determined a safe procedure has there a check at the beginning of each shift. The technician, however, did not lubricate the machine that was stuck during the process and caused sparks.

In the first incident that happened in the KKS 6 machine at the Assembly Decoration 1 (AD1), unsafe actions were said as the primary cause. In other words, the workers did not carry out the work by the Standard Operating Procedure (SOP). Notably, the workers did not thoroughly check the dais that they did not aware of if it should be lubricated to be able to spin.

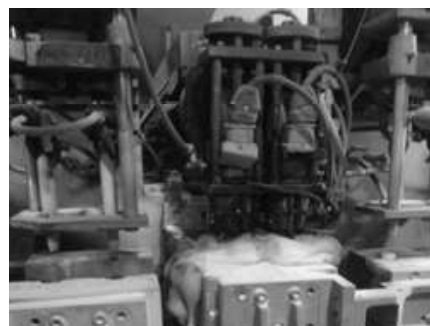
Figure 2. The VK4 Machine after the Fire in the Blow Molding (BM) Area

The second fire incident took place in the Blow Molding (BM) area at the VK4 machine on 18 March 2018 at 18:30 WIB. According to the respondent, the incident began when the "as deplashing" nut was released and did not touch the switch censor. Thus, the mold was in the campling condition in the upper position. Figure 2 displayed the state of the machine after the fire.

The second fire incident took place in the Blow Molding (BM) area at the VK4 machine and was caused by both unsafe conditions and unsafe action. When the incident occurred, the on-duty operators were not on the location; one was taking a break, and the other one was absent. Thus, in the beginning, no one was aware of the broken machine that led to the fire.

The second incident, the fire in the VK4 machine at the Blow Molding (BM) area, was a result of both the human error and the machine error. First, the two on-duty operators left the machine unsupervised when they were supposed to supervise it. Second, the engine was broken in the beginning; thus, when it was operated, it produced sparks that caused the fire.

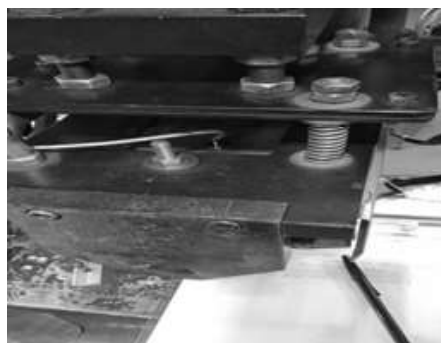
Figure 3. The KKS 6 Machine after the Fire in the Assembly Decoration 1 (AD1) Area.

The third incident reoccurred at the same machine and area as the first incident; the KKS 6 machine in the Assembly Decoration 1 (AD1) area on 30 March 2018. However, different from the first incident, this incident happened during shift three at 02:30 WIB when the initial setting was carried out. The incident, as affirmed by the respondent, occurred after the technician finished the maintenance with the electrical short circuit in the heating element. When trying to set up the machine, its temperature suddenly reached 500° Celsius in the heater that resulted in a small fire. Figure 3 showed the condition of the machine after the fire.

Another unsafe action caused the third fire at the KKS 6 machine in the Assembly Decoration 1 (AD1) area. The incident happened when a worker carried out the maintenance of the machine. However, the temperature drastically arose to 500°

Celsius and triggered the sparks on the rubber dais of the KKS 6 machine.

The third incident occurred at the same location as the first one did; the Assembly Decoration 1 (AD1) area, which was caused by an unsafe condition (unsafe machine). It was reported that when carrying out the maintenance, the worker noticed that the machine temperature was unstable and drastically arose to 500° Celsius that later initiated fire.
