Case Report

Zirconia crown restoration on endodontically treated first premolar: A case report

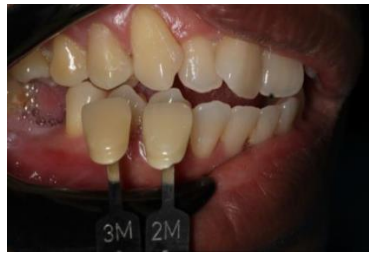
Figure 2. Color determination of the crown using the shade guide.

On the first visit, the patient was given KIE, DHE, and informed consent forms. After that, a one-time root canal treatment was performed. Subsequent visits are planned for post-placement and crown preparation. The patient was instructed to gargle with povidone-iodine 1% for 30 seconds. adjustment of tooth color using a shade guide (2M3) (Figure 2).

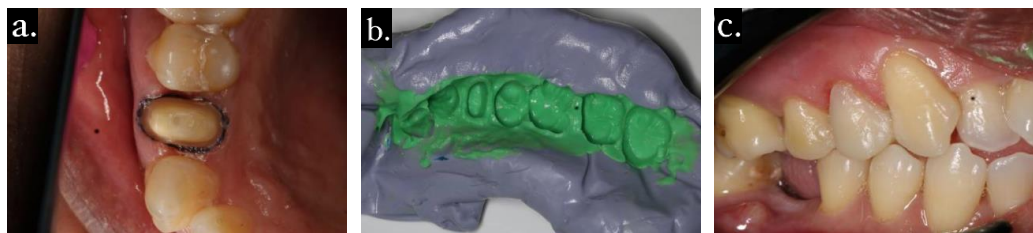
Figure 4. a. Occlusal view of crown preparation; b. Double-impresion mold; c. Temporary crown insertion.

Gingival management was carried out using a retraction cord, followed by crown preparation with a deep chamfer preparation design, with 0.7 mm wall removal and 1.5 mm occlusal removal, and final subgingival preparation using a round end taper fissure diamond bur (Figure 4a). Maxillary impressions were made with double impression elastomeric materials (Figure 4b) and antagonistic impressions with irreversible hydrocolloid (alginate) impression materials. The bite registration was made using polyvinyl siloxane and continued with the manufacture of a temporary crown (Figure 4c).

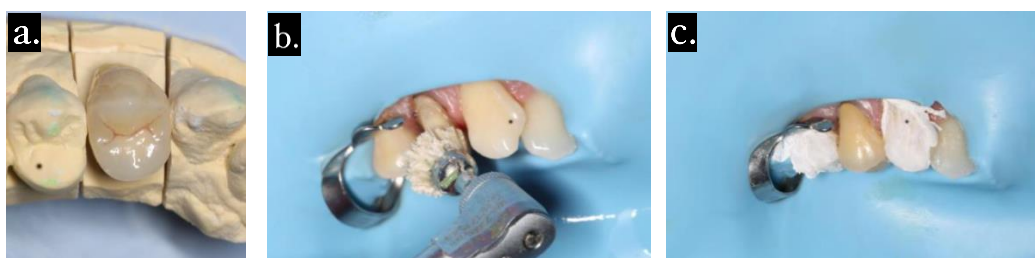
Figure 5. a. Occlusal view of zirconia crown; b. Cleaning teeth with brush and pumice; c. Zirconia crown insertion.

The next visit was to try on a fixed crown, check occlusion, articulation, and adaptation to the surrounding tissue (Figure 5a). The rubber dam was placed before the teeth were cleaned with a brush and pumice (Figure 5b). Surface treatment of the zirconia crown was carried out followed by cementation using self-adhesive resin cement (Figure 5c).
