| Case Report |

Rehabilitation of anterior teeth trough endorestitution

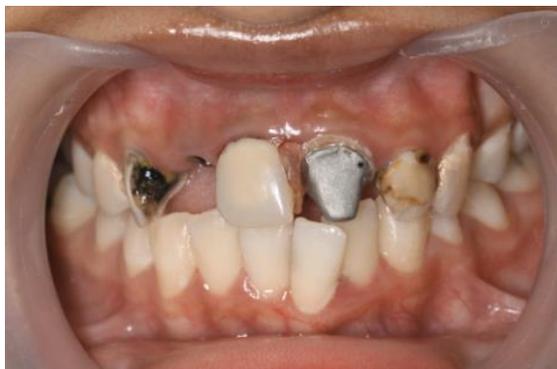
Figure 1. Intraoral photo.

The result of intraoral examination (Figure 1), tooth 13 with Class IV caries black classification, caries involves mesial area to the incisal area zand the EPT vitality test shows the number 5. Tooth 12 with gangren radix, nonvital and on the radiographic appearance it appears gutap percha remnants in the apical third area and radiolucent with diffuse borders in the apical area. Tooth 11 was previously endodontic treated, inserted metal post and restored porcelain Fused to Metal (PFM) crown.

Tooth 21 was inserted metal post with loose of crown. On radiographic examination there is a radiopaque appearance in the crown area area and radiopaque appearance at canal area (metal post at coronal third to middle third area and gutta percha at apical third area). Tooth 22 was filled with class IV composite restoration with depth of cavities very

close to the pulp. And there was caries V on the cervico labial area and the EPT examination shows number 3, the vitality is reactive. On tooth 23 there was class III caries on the mesial area and positif to vitality test. On examination of saliva, Hydration shows the number 45 seconds, bubbly viscosity, pH 6.8, Quantity 4.5 mm/5 minutes and buffer capacity shows the number 8.

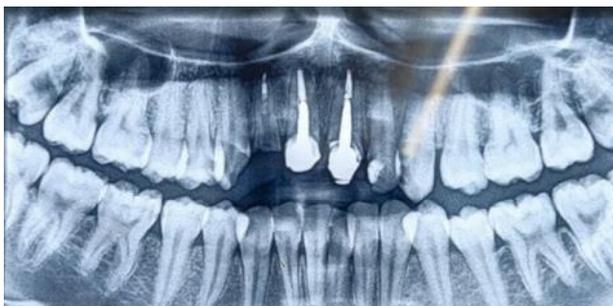
Figure 2. Panoramic radiography.

Based on the subjective, intraoral and radiography examination (Figure 2), the diagnoses of those teeth were : 13 irreversible pulpitis with normal apical, 12 previously treated tooth with normal apical, 11 previously treated tooth with normal apical, 21 previously treated tooth with normal apical, 22 irreversible pulpitis with normal apical, 23 reversible pulpitis with normal apical.

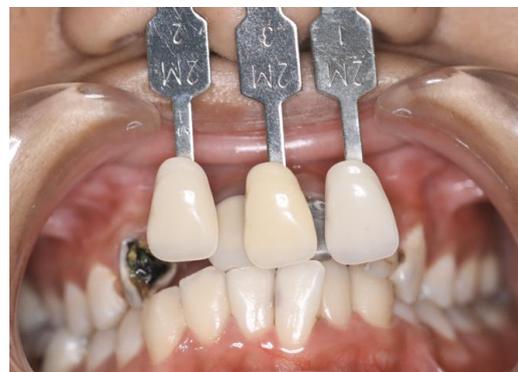
Figure 3. Colour shading.

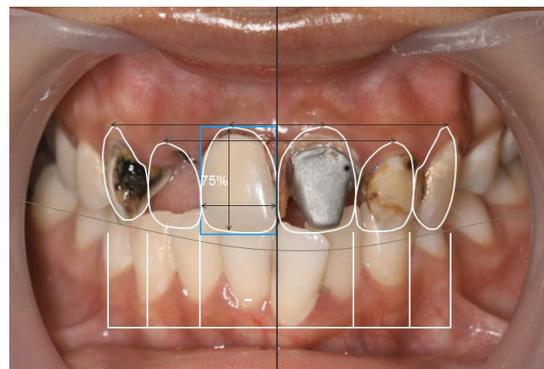
Figure 4. Smile design.

and disposable nurse caps. Treatment was carried out in a negative pressure room with aerosol suction. The health protocol procedure during this pandemic is carried out at the beginning of each patient visit. The patient was instructed to gargle with Povidone Iodine 1% for 30 seconds. Furthermore, subjective, objective, supporting examinations such as panoramic rontgen and saliva tests are then carried out and a diagnose was straighten. Patients also get dental health education, and information about her dental health conditions and the treatment plan and also informed consent and informed to consent. The patient was taken impression for study model, profile photos, intraoral photos, colour shading use (Vita 3D Master 2M2) (Figure 3) and making a digital smile design (Figure 4). Smile design consist of Central Incisor Width/Height Ratio, Mesial Inclination, Midline Placement, Gum Line Margin Height, Gum line symetric, Flossing Contact Point, dan Old Dentistry.

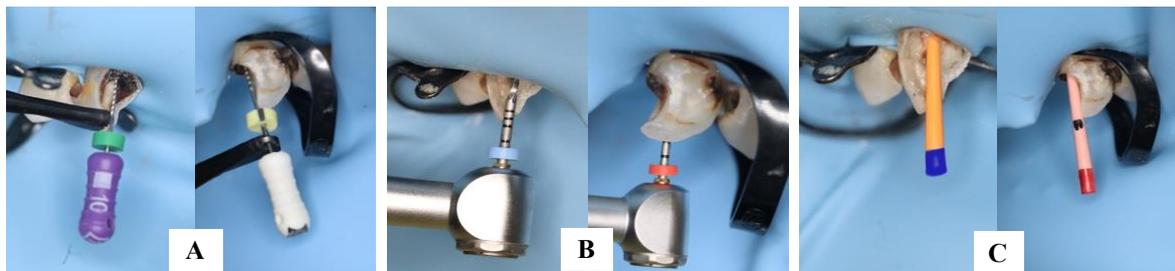
Figure 5. (A) Working Length Measurement. (B) Root canal preparation 13 dan 22. (C) Guttap percha trial.

On the second visit, after rubber dam isolation, one visit endodontic treatment was carried out on teeth 13 and 22. First access opening was performed using endo acces bur, glide path management using K-File #10 and rotary file (ProGlider) with root canal lubricant, obtained working length with apex locator (Tooth 13 : 21 mm and Tooth 22 : 19 mm) (Figure 5A). Furthermore, apical gauging was performed with K-File #30 on tooth 13 and K-File #25 for tooth 22. Then the root canal preparation was carried out using a pressureless crown down technique using a

rotary protaper next file (X3: 30/.07) for teeth 13 and (X2: 25/.06) for tooth 22 (Figure 5B). Followed by irrigation with Sequence of irrigation (5.25% NaOCl - sterile distilled water - 17% EDTA - sterile distilled water) using 1 side-vent 30G needle syringe and activated of sonic agitation. The root canals were dried and followed by obturation using the single cone technique using gutta percha points (X3: 30/.07) tooth 13, (X2: 25/.06) tooth 12, resin-based sealer paste and restored temporary with Cavit temporary filling (Figure 5C).

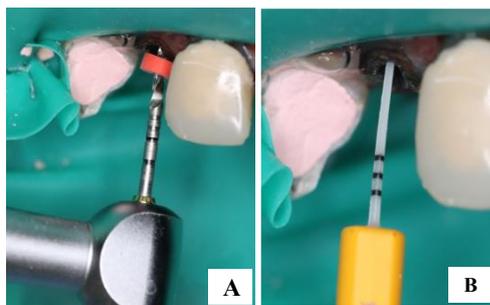
Figure 6. (A) Preparation on tooth 12. (B) Activation.

Still on the second visit, Tooth 12 was retreated endodontically. Remaining gutta percha was removed using guttap solvent and headstrom file. The canal was irrigated with 5.25% NaOCl - sterile distilled water - 17% EDTA - sterile distilled water using a syringe with 1 side-vent 30G needle and activated sonic agitation. Next, a glide path was performed using K-File #10 and a rotary file (ProGlider) with root canal lubricant, the working length was obtained with the apex locator (Gigi 12: 15mm). Apical Gauging K-File #25. The root canal preparation was continued using a rotary protaper file next (X2: 25/.06) (Figure 6A).

Sequence irrigation (NaOCl 5.25% - sterile distilled water - EDTA 17% - sterile distilled water - Chlorhexidine 2% - sterile distilled water) using a syringe with 1 side-vent 30G needle and activated sonic agitation (Figur 6B). The root canals were dried with endo suction and sterile paper points. Furthermore, Ca(OH)₂ dressing and temporary filling were carried out.

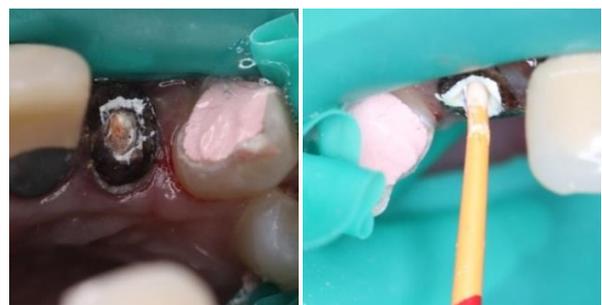
Figure 7. Obturation.

At the 3rd visit, tooth 12 was obturated. Tooth 12 was evaluated, the patient had no complaints. Oral extras had no abnormalities, on percussion (-), the temporary filling still intact. Next, a rubber dam is installed. The temporary filling was taken, then irrigated with Sequence irrigation (2.5% NaOCl - sterile distilled water - 17% EDTA - sterile distilled water) using a syringe with a 30G needle 1 side-vent and activated sonic agitation. The root canals were dried with endo suction and sterile paper points. Filling the root canal of tooth 12 using the single cone technique using gutta percha point X2 (25/.06) with resin-based sealer paste (Figure 7). The cavity is closed with a temporary filling. Then the patient was referred to a periodontology department for crown lengthening.

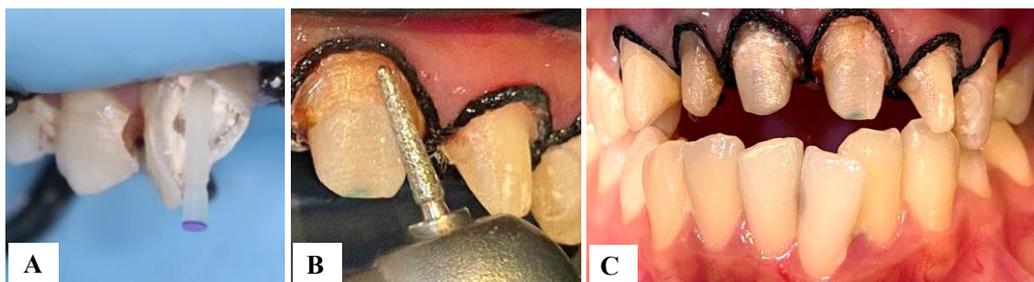
Figure 8. (A) Fiber Post Trial. (B) Core Build Up. (C) Gingival Retraction.

The 4th visit was carried out a week after the crown lengthening. During this visit, metal post on tooth 21 was removed, and post and crown preparations were carried out. After isolation using rubber dam, tooth 21 metal post were removed using ultrasonic. Coronal middle third of gutta-percha was removed with post drill on tooth 13, 12, and 22. The gutta-percha that removed in teeth 13 was 16mm, in tooth 12 was 12mm, tooth 22 was 13mm, and Fiber post trial on those regio include 21 (Figure 8A). Cementation of fiber posts with self-adhesive cement. The core build up uses a dual cured core built up resin. All porcelain crown preparations for teeth 13, 12, 11, 21, 22, and 23 used round end tapered fissure diamond burs converging towards the incisal with chamfered preparation endings. The preparation was smoothed using a fine finishing bur (Figure 8B). Gingival management using a retraction cord (Figure 8C). Taking impression with two-step technique using double impression (putty and light body) and taking impression for antagonist regio with alginate. Making bite registration using polyvinyl siloxane. Creating temporary crowns for teeth 13, 12, 11, 21, 22, and 23.

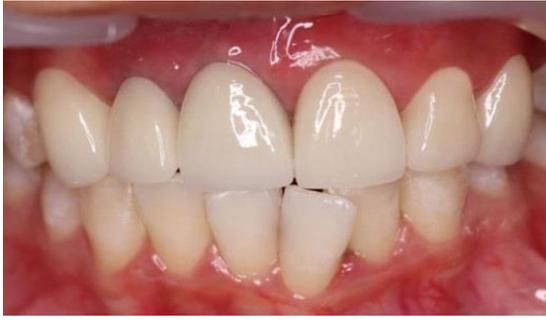
Figure 9. After cementation.

Rubber dam isolation, temporary crown taken. Next, try to install an all porcelain (lithium disilicate) fixed crown. Anatomical adjustment and color resemblance, occlusion and articulation, proximal contact, restoration adaptation to surrounding tissue. After everything was in good condition, continued etching on the crown (9% buffered hydrofluoric acid) for 90 seconds then rinsed, dried and covered with silane and left for 60 seconds. Apply self-etch adhesive to the tooth surface, spray with light air and light curing for 20 seconds. Insertion of all porcelain crowns on teeth 13, 12, 11, 21, 22, and 23 using dual cured cement resin (Figure 9).
