Case Report

Management of ledge and overprepared access cavity in mandibular second molar

Department of Conservative Dentistry, Faculty of Dentistry, Universitas Trisakti, Jakarta, Indonesia

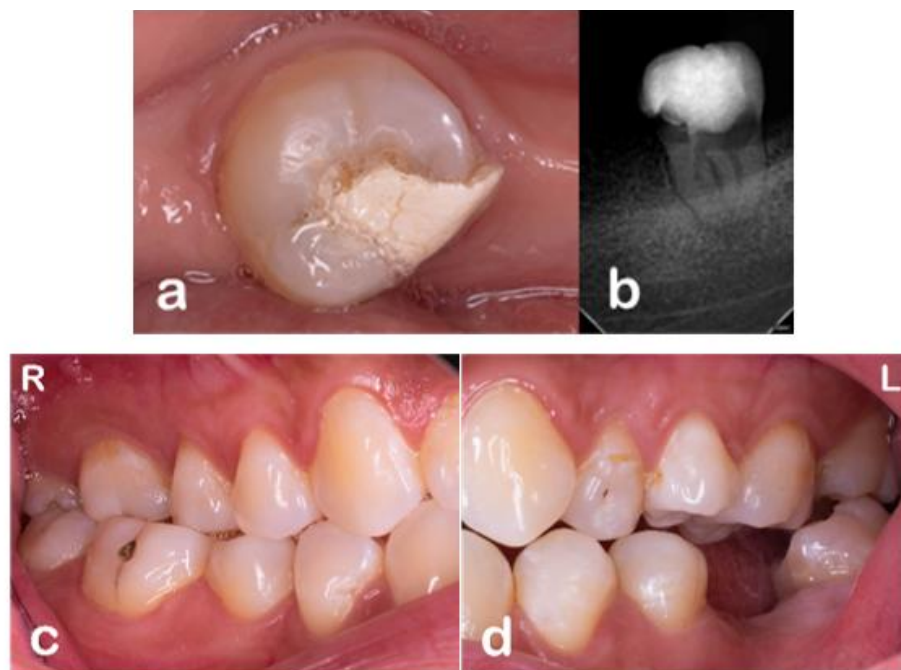
Figure 1. Pre-operative evaluation: (a) Clinical condition of tooth 37; (b) Pre-operative periapical radiograph; (c) Right side occlusion; (d) Left side occlusion demonstrating the absence of tooth 36 and mesial tipping of tooth 37.

A 33-year-old female patient was referred by her previous dentist to continue her dental treatment. The patient is currently asymptomatic, although she previously experienced difficulty eating and throbbing pain. An intraoral examination revealed tooth 37 with a temporary filling extending subgingivally. Tooth 37 exhibited mesial tipping due to the absence of tooth 36, while tooth 27 remained intact. Radiographic examination revealed a temporary filling on the occlusal surface of tooth 37, a radiolucent area on its mesial aspect, excessive access cavity preparation from the pulp chamber extending distally, and ledge formation in the mesial root canal. The diagnosis was previously initiated therapy with normal apical tissue [Figure 1]. The patient provided written informed consent for the treatment and for the use of clinical information and images for publication.

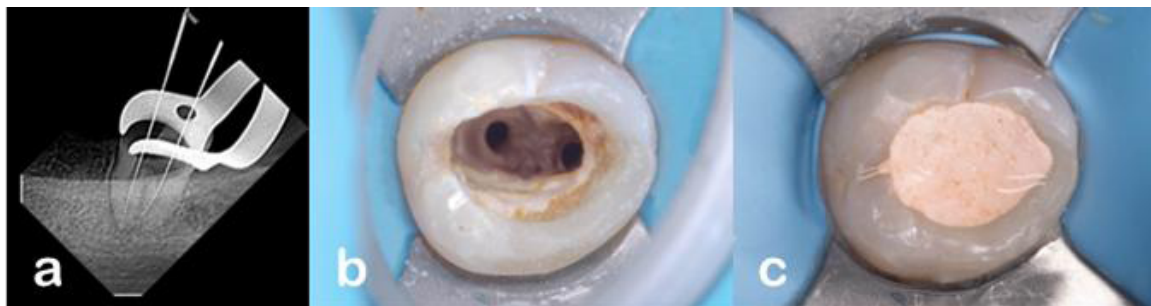
Figure 2. First visit of root canal treatment: (a) Removal of temporary restoration and carious tissue; (b) Placement of teflon tape and posterior sectional matrix; (c) Artificial wall build-up with doughnut and snowplow technique.

Root canal treatment was performed under rubber dam isolation. Temporary restoration and carious tissue were removed using an ultrasonic scaler (Satelec) and a carbide round bur #2 (SS White). An artificial wall was constructed using the doughnut and snowplow techniques with a packable resin composite [Figure 2]. Biomechanical preparation was initiated using pre-curved stainless-steel K-files #10 and #15 to explore, negotiate, and establish a glide path past the ledge. A rubber stopper indicator on each file was used to determine the orientation of root canal curvature in both roots. After the endodontic files had navigated past the ledge, the working length was established with an electronic apex locator and verified using a periapical radiograph. To preserve the canal shape and minimize the risk of iatrogenic error, all rotary files were pre-curved

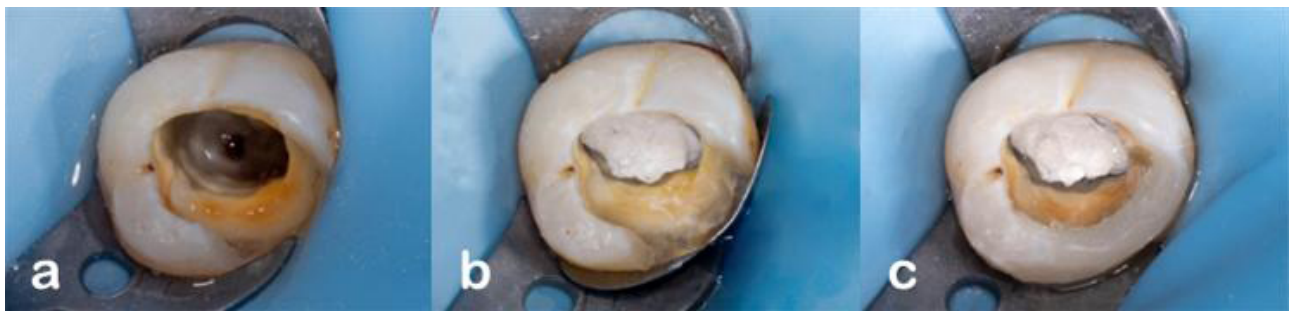
Figure 3. First visit root canal treatment: (a) Working length determination; (b) Biomechanical preparation; (c) Placement of intracanal medicament and temporary restoration.

before use. Glide path preparation (C-Path Rotary Files, Fanta) was performed using #13/.02, #16/.02, and #19/.02 with a pecking motion to the working length. Heat-treated files (AF Rotary Files, Fanta) were used for biomechanical preparation up to size #25/.04. Each consecutive file was accompanied by irrigation with 5.25% sodium hypochlorite (NaOCl) and apical patency was maintained with a K-file #10. Biomechanical preparation continued until one-third of the file flutes filled with white dentin. Apical gauging was performed with a K-file #25, followed by the application of calcium hydroxide as an intracanal medicament and temporary restoration [Figure 3].

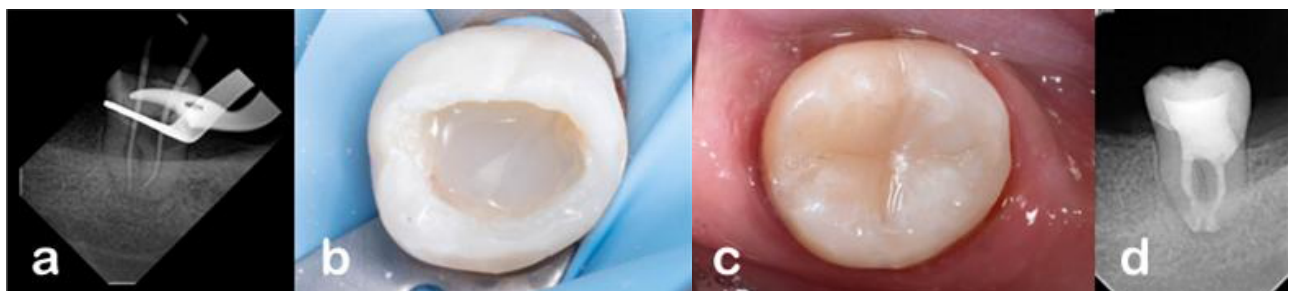
Figure 4. Second visit of root canal treatment: (a) Master gutta-percha cones verification and obturation; (b) Intracanal barrier with flowable bulk-fill resin composite; (c) Restoration with packable composite; (d) Post-operative radiograph.

medicament calcium hydroxide. This was achieved by irrigating with 5.25% sodium hypochlorite until the root canal was thoroughly cleaned. Master gutta-percha cones #25 were then carried to the working length and verified using a periapical radiograph. Final irrigation was performed using 5.25% NaOCl and 17% EDTA (ethylenediamine tetra-acetic acid), activated with an endoactivator (Eddy, VDW). Each successive irrigation solution was followed by rinsing with distilled water. The root canal was then dried until slight moisture remained, as indicated by the remaining 3-4 mm of moisture on the paper point. Obturation was completed with bioceramic sealer, warm vertical compaction in the mesial root, and a single-cone obturation technique in the distal root. A flowable bulk-fill resin composite (SDR flow+, Dentsply) was chosen for the intracanal barrier, and the final restoration was completed using packable resin composite (Micerium UD3 and Palfique LX5 A2) [Figure 4].
