Case Report

An aesthetic rehabilitation of fractured anterior maxillary teeth with multiple diastema

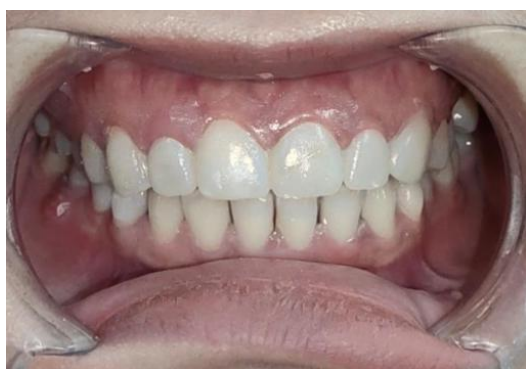
Figure 3. Mock up fabrication

At the second visit, a general review of symptoms and dental examination showed no abnormalities. Rubber dam isolation was applied, and mock-up fabrication was carried out using the diagnostic wax-up. The patient approved the proposed aesthetic changes based on the mock-up trial (Figure 3).

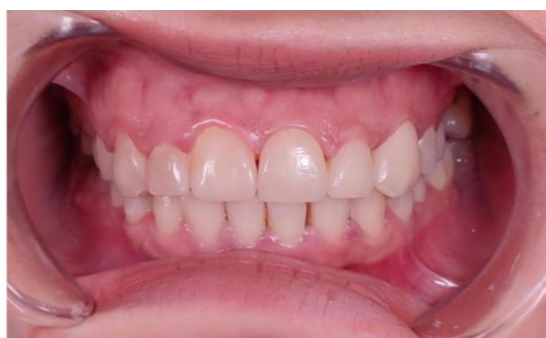
Figure 7. Try-in of crown and veneer.

At the one-week follow-up appointment, the patient still reported no complaints or discomfort. Extraoral examination revealed no abnormalities. Intraorally, the provisional crowns and veneer were intact and in good condition. Percussion tests on teeth 21, 22, and 23 were negative, and the surrounding gingival tissues appeared healthy. The provisional restorations were gently removed. A clinical try-in of the definitive lithium disilicate crowns and veneer was performed to assess marginal adaptation, contour, and occlusion. The restorations demonstrated satisfactory fit and aesthetic harmony with the adjacent dentition (Figure 7).
