Optimization of Occupational Safety and Health Implementation in a Chemical Analytics Laboratory

Table 1. Recapitulation of Occupational Safety and Health Checklist Answer Results in the Chemical Analytics Laboratory in University X Surabaya in 2020

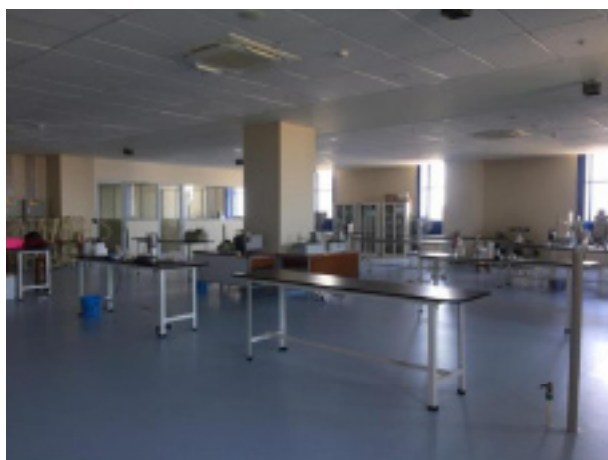
Figure 1. Condition of the Chemical Analytics Laboratory in University X Surabaya in August 2020

The condition of the benches and tables that can be found in the chemical analytic laboratory looks good and is not harmful. The tables used for the implementation of activities in the laboratory are a set of tables coated with an anti-corrosion coating and equipped with shelves and storage drawers. However, there are wood materials on the tables and chairs that are not fireproof. This certainly requires fire protection efforts as this could potentially lead to a fire risk. Fire is a pure risk or accidental risk, which in the event of an accident can cause sudden loss

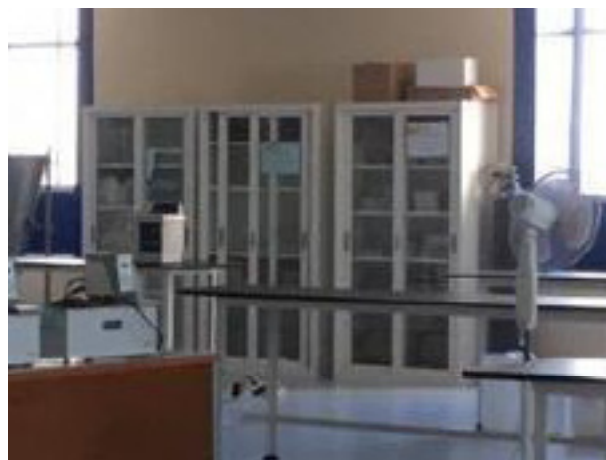
Figure 2. Condition of Storage Lockers at the Chemical Analytics Laboratory of University X Surabaya in August 2020

Facilities that can be utilized by laboratory users to store laboratory equipment are lockers or storage cabinets. Based on the observations, cabinets and storage lockers are closed and neat, and there are no excessive piles of goods so the risk of being hit by goods is very low. Items stored in the cabinets are items that are temporarily not used. Meanwhile,

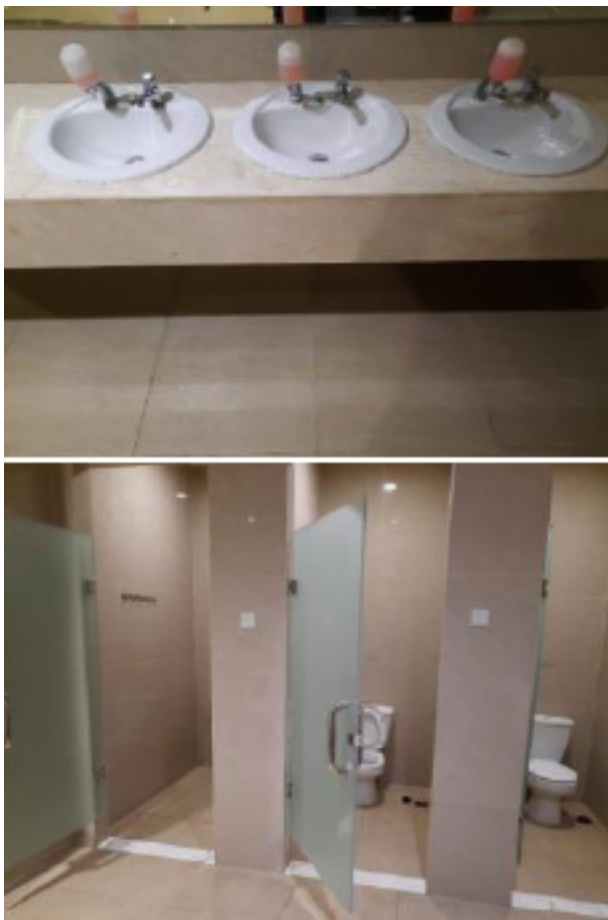
Figure 3. Condition of Sinks and Toilets at the Chemical Analytics Laboratory of University X Surabaya in August 2020

Maintained cleanliness in the work area will create comfort. Based on the observation results, the laboratory room in general is clean and neatly arranged for the existing items. There are 2 sinks

for handwashing on each right and left side of the laboratory table. However, toilets are available outside the laboratory area, which is a public facility on the 7th floor of the building. In addition, each floor has a separate toilet between male and female personnel. In the men's toilet, there are 3 latrines, 3 urinals, 2 sinks, 1 trash can, and 1 automatic hand dryer. Meanwhile, in the women's toilets there are facilities like in the men's toilets but there are no urinals. Completeness of toilet facilities is no less important to note. Completeness of toilet facilities includes latrines, sufficient clean water, flushing tools, trash cans, hand washers, and soap. (Ministry of Manpower Regulation, 2018). Toilet facilities in the area around the chemical analytics laboratory have adequately complied with the facilities as stipulated in the act.

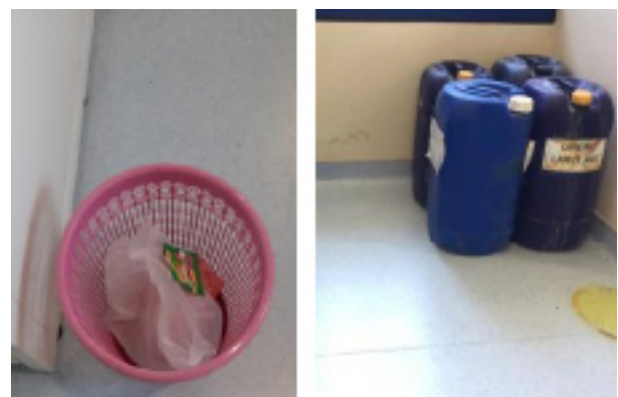
Figure 4. Condition of Waste Disposal at the Chemical Analytics Laboratory of University X Surabaya in August 2020

Another personnel facility is the trash cans. Based on the observations made, the trash cans provided are not closed. This is similar to research conducted by Pertiwi, Joko, and Dangiran (2017),

stating that the existence of trash cans without lids can cause waste dilution if it is full. Unclosed trash can allow human contact with microbes and odors, and it is also unsightly (Pertwi, Joko and Dangiran, 2017). Also, organic and inorganic waste cans are also found in one container. It is certainly not in accordance with the applicable regulations that the sorting of types of waste must be provided separately, labeled, and covered and made watertight (Ministry of Manpower Regulation, 2018).

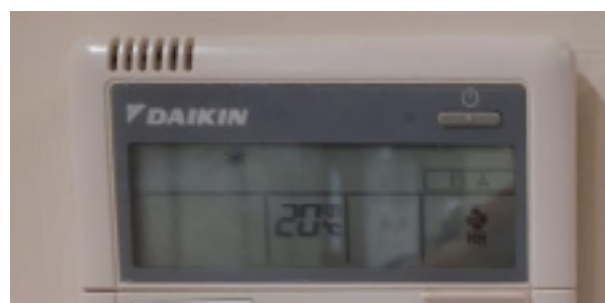
Figure 5. A Temperature Monitoring Tool at the Chemical Analytics Laboratory of University X Surabaya in August 2020

Based on the results of observation, the chemical analytics laboratory room temperature is 20°C. The temperature is in accordance with the permissible laboratory temperature ranging from 20°C to 25°C (Ministry of Health Regulation, 2013). Maintained room temperature will create good humidity of the room to minimize damage to the equipment in the laboratory. This aims to reduce direct sun exposure and keep laboratory temperatures within the permissible limits. The temperature is also closely related to the metabolism of the body. Cold temperatures can reduce efficiency and cause stiff complaints or a lack of muscle coordination. Meanwhile, hot air conditions can decrease work performance and affect the comfort of the occupants of the room. Changes in blood circulation can also be caused by room temperature (Aziziyani, 2019).

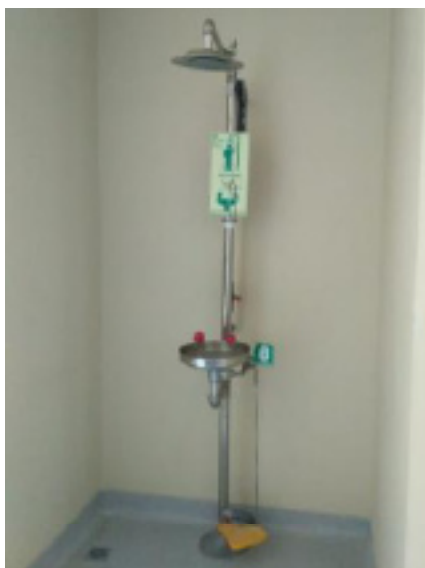
Figure 6. Condition of an Eyewash and Safety Shower at the Chemical Analytics Laboratory of University X Surabaya in August 2020

In addition, hazard risk control in the laboratory is carried out with complete safety equipment in the form of eyewash and safety showers in the chemical analytics laboratory. Such equipment is important for activities that use chemicals in the laboratory. The risk of chemical exposure can injure the users. If the eyes are exposed to chemicals, eye rinsing needs to be done in the eyewash section so that there are no eye injuries. Also, safety showers are used when the laboratory users spill chemicals into themselves to rinse exposed parts of the body (Stauffer *et al.*, 2018). Based on observations, safety showers can be reached by laboratory users in less than 10 seconds from the laboratory.

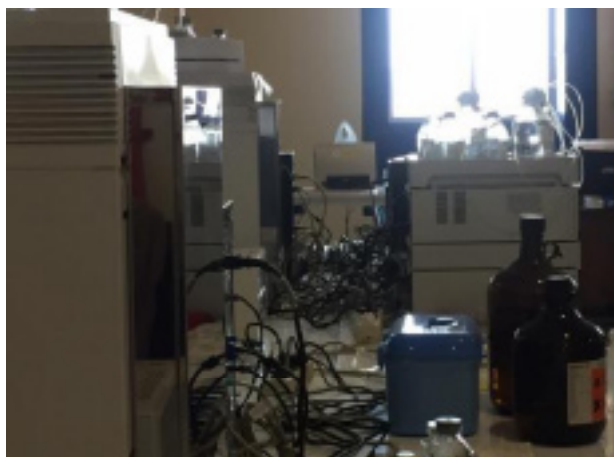
Figure 7. Condition of Cable Setup in the Chemical Analytics Laboratory of University X Surabaya in August 2020

Service in the laboratory is an important factor supporting laboratory activities. Based on the observations made, electrical installations, handwashing places, and water are functioning properly. However, the arrangement of cables as laboratory equipment is still not organized, so it has the potential to pose danger of electrical circuits or

electrocution for laboratory personnel. Based on the findings of previous research, electrical circuits can cause uncontrollable sparks due to untidy installation, which can cause a greater danger of fire (Andu, 2019). This can lead to material losses and even fatalities. Improvements to the problem must be done immediately so that the potential danger does not occur to laboratory personnel.

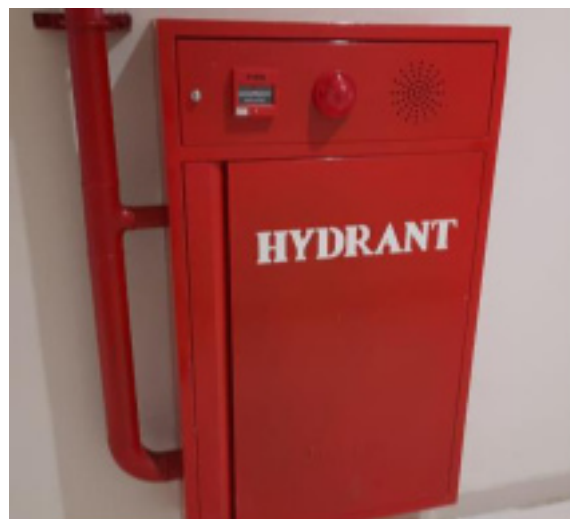
Figure 8. Condition of Fire Hydrants and Alarms in the Chemical Analytics Laboratory of University X Surabaya in August 2020

Based on the classification of fire disasters, fires that have the potential to occur in the chemical analytics laboratory are fires caused by solid materials except metals such as wood, paper, etc. (class A), fires of liquid materials or flammable gases such as alcohol (class B), fires involving electrical equipment (class C), and fires in solid metal objects (class D) (National Fire Protection Association (NFPA) 10, 2018). One of the efforts to secure in an emergency is the existence of an emergency information system. An emergency is caused by a

fire. Alarm systems and hydrants for emergencies are well available. Alarm checks in maintenance efforts are carried out once a month using a checklist.
