Evaluation of the Implementation of the Local Exhaust Ventilation System in the Testing Laboratory

Yudha Andaka Setyawan^{1,2}, Shintia Yunita Arini³, Sri Widodo⁴

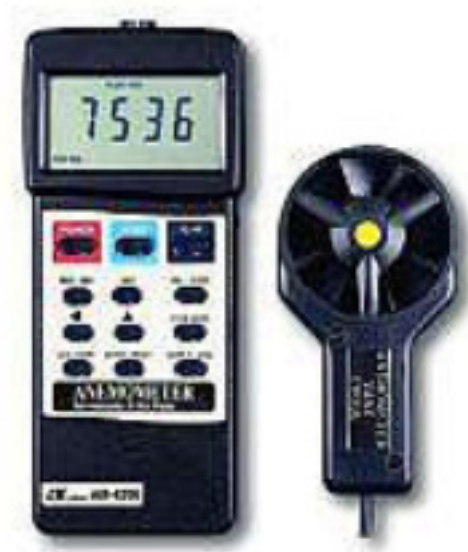
Figure 1. Anemometer

The next step after calculating the cross-sectional area of the Inner Circle Hood was to measure the flow velocity. The flow velocity measurement was done using the Lutron AM-4206 Anemometer.

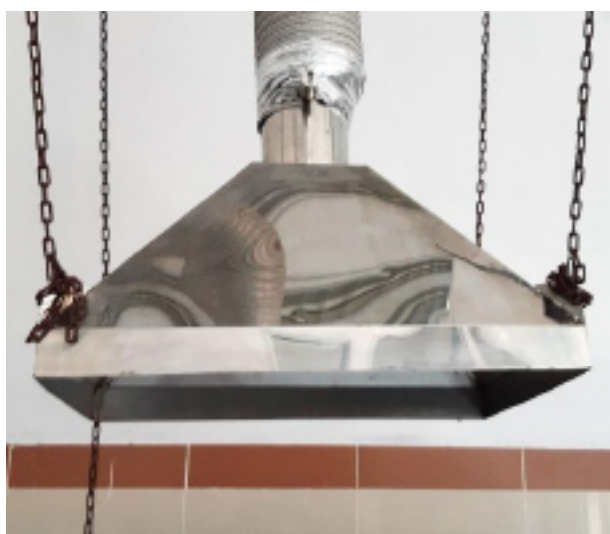
Based on observations in the AAS room, the hood used was a hanging receiver canopy hood. The placement of the hanging hood was supported by providing an iron chain at each of the 4 corners so that it did not sway while operating.

The inner hood dimension was used to measure the cross-sectional area of the flow rate in order to determine the actual suction volume. Therefore, the cross-sectional area used was the Cylindrical Inner Hood. The Cylindrical Inner Hood diameter was 0.012 m, so the calculation of the cross-sectional area of the Inner Circle Hood was 0,011304 m².

The hood was also equipped with a manual valve which functioned to regulate the speed of the flow rate and protect the equipment from dust coming from outside the room when the tool was not in use.

The use of a manual valve was indicated by an arrow which was made using a black marker, so that

Figure 2. A Hood installed on Hitachi ZA3000 of the Testing Laboratory at the UPT of Occupational Safety Surabaya in 2020

if it was used in the long term, it had the potential to fade due to rubbing or exposure to liquid or chemical vapors.

The hood output that contains a manual valve mark with a black permanent marker should be replaced with a more permanent mark. Manual valve

signs are caution signs that should use the material that is durable because, as safety signs, they play a vital role in work environments (Reis, Duarte and Rebelo, 2015). This action aims to reduce the potential for missing or faded manual valve signs due to friction or due to reactions with the local environment. The provision of safety signs should, therefore, follow the safety sign recommendations (ANSI, 2011).

In this case, the evaluation is only given to the hood on the four corners of the canopy hood using a chain made of corrosive materials. Consequently, when the observations were made by the researchers, the chain had begun to look corrosive, marked by a change in its color. The impact of the chain that has been corrosive is the reduced durability in holding the canopy hood to maintain its position against the source of contaminants. The hood will not effectively capture the contaminant source if the hood is shifted towards a contaminant source. Therefore, maintenance and monitoring of the material needs to be considered since maintaining the resistance of the material is a necessity to prevent problems in the future (Zhivov *et al.*, 2001).

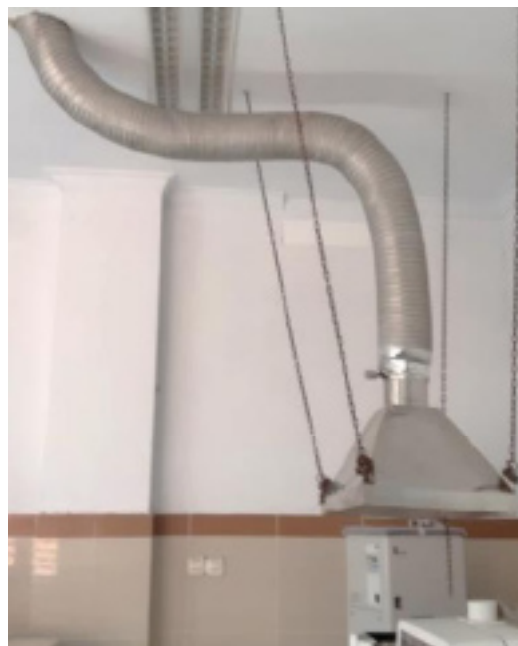
Based on observations in the AAS room, the duct was cylindrical with a flexible duct-type made of stainless steel to be able to withstand heat and metal vapor when the AAS flame and furnace were operating. This flexible duct had 3 elbows/corners with a diameter of 15 cm and a length of approximately 5 meters

Figure 3. A Duct installed on Hitachi ZA3000 of the Testing Laboratory at the UPT of Occupational Safety Surabaya in 2020

There is no recommendation for the maximum number of duct elbows from the tool specifications. However, according to the American Society of Heating, Refrigerating and Air-Conditioning Engineers (ASHRAE), every LEV Systems must have duct components that comply with the standards and their designations (ASHRAE, 2016). Each duct must have 2 or 2.5 diameters in the center line radius (Gupta, 2013). This is expected to reduce

the air turbulence in the duct flow. Of the 3 duct elbows in the LEV system in the AAS room, all elbows have met this requirement.

The shape of the ducting system is in accordance with the tool specifications, namely in the form of a cylinder with a diameter of 15 cm (Hitachi, 2013). Cylindrical ducts can result in better distribution of airflow to the outside of the room than duct in the rectangular shape (Aydin and Ozerdem, 2006). Cylindrical ducts can reduce the turbulence in the duct flow so that airflow does not experience a significant reduction from the hood to the fan output.

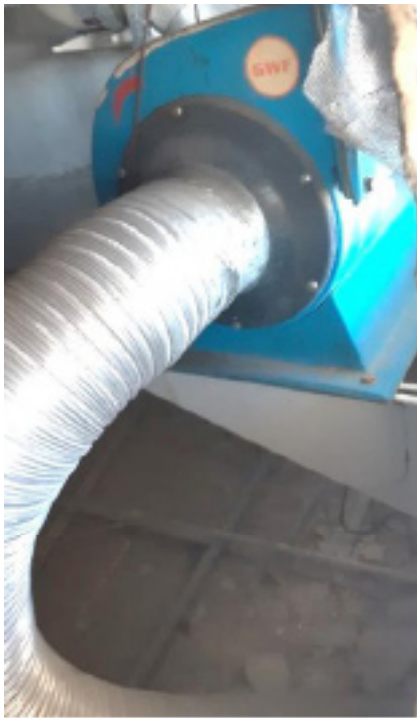
Based on observations on the building roof of the UPT of Occupational Safety Surabaya, the pump machine used was Hitachi EFOUP, while the fan in the LEV system was GWF. The pump machine used 0.5 HP (Horse Power), 220 Volt and 3.8 Ampere power and was Induction Motor and Condenser

Start. This Hitachi pump machine was capable of driving the fan with an average speed of 1,430 revolutions per minute.

Figure 4. A Fan installed on Hitachi ZA3000 of the Testing Laboratory at the UPT of Occupational Safety Surabaya in 2020

The fan used was a forward-curved-blade centrifugal fan. This type of fan is the right choice for fume contaminants, and the fan is relatively quiet when operated (ASHRAE, 2016). The materials used to make the fan are not known. In fact, the fan looks

to be in good condition during usage from mid-2016 until now. It proves that the fan uses materials which are heat resistant and not corrosive quickly. Choosing a good fan can increase performance so that the fan can work well for a long time. However, if the selection of the fan is not in accordance with its designation, it can lead to poor work efficiency of the fan and result in increased energy use (Gunner, Afshari and Bergsøe, 2015; Zhou *et al.*, 2021).

The fan was placed right under the roof of the building and well protected from rain and direct sunlight, which can extend the life of the pump machine and fan and can increase economic efficiency (ASHRAE, 2016). There was damage to the wire mesh attached to the end of the fan. This is because the temperature and metal vapor resulting from the analysis can damage the wire mesh because the mesh uses a material that is not anti-heat and anti-corrosive. Thus, the wire mesh experiences heat and chemical reactions so that it becomes damaged (ASHRAE, 2016). This must be well-considered because maintaining the resistance of the material is a necessity to prevent problems in the future (Zhivov *et al.*, 2001).

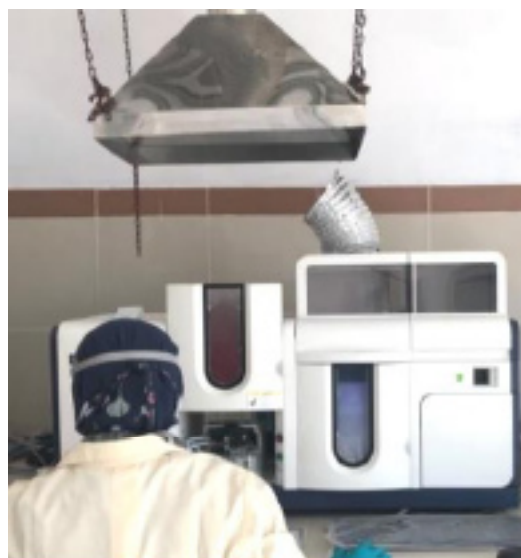
Based on observations shown in Figure 4, the analyst who operated the AAS tool was in a safe zone because it was outside the AAS flame airflow. Movement of contaminated air away from workers creates a clean air work zone and later channels contaminated air into the hood (Olander *et al.*, 2001).

Figure 5. . An Analyst was operating the AAS tool of the Testing Laboratory at the UPT of Occupational Safety Surabaya in 2020
