# THE ANALYSIS OF FIRE ENGINEERING AND ADMINISTRATIVE CONTROL AT BUILDING X UNIVERSITY Y YEAR 2018

**Fandita Tonyka Maharani, Azizah Musliha Fitri, Arga Buntara**

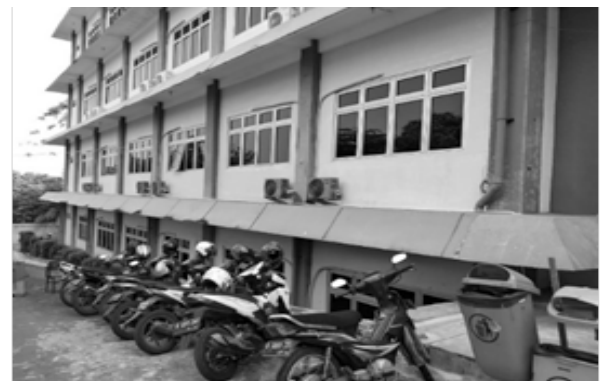
**Figure 2.** Half of the Building Located Underground

Around 500 people inhabited Building X University Y, including students, lecturers, and administrative workers. The building was used every day for learning purposes. The structure consists of five floors. The first, third, and fourth floors are used for lectures. Offices for lecturers and the heads of study programmes are located on the second floor. The auditorium is situated on the top floor. Based on our observation, half of the first floor located underground (Figure 2).

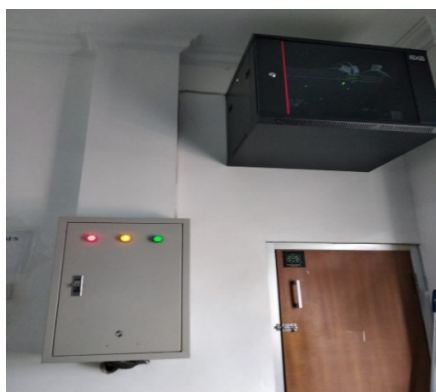
**Figure 3.** Electrical Control Panel

We found that electrical installations of cabling and associated devices, such as control panels (see Figure 3), served as the main hazard sources in the structure. Regarding control panels, they were likely to be opened by unauthorized individuals due to their exposed locations. Furthermore, classrooms and offices utilized numerous electronic instruments, including personal computers, printers, water dispensers, and slide projectors.

Electrical control panels as hazard sources must have adequate precautions, including safe key use. Therefore, only authorized personnel are allowed to access it. The electrical wiring must be monitored regularly to ensure that they are in proper condition and would not cause any fire. The electronic devices must be maintained properly.

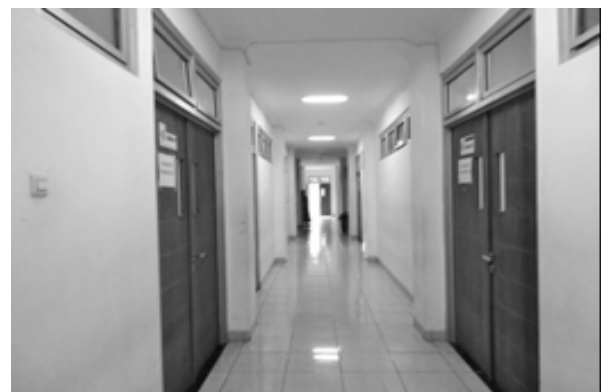
**Figure 5.** The Corridor of the Second Floor

corridors separated from other parts of the building (Ministry of Public Works of Indonesia, 2008). These corridors must have walls which are able to resist fire for at least one hour. Based on NFPA 101B (2002), a floor area exceeding 185 m<sup>2</sup> or with travel distance to the primary means of escape exceeding 23 m should be provided with two primary means of escape. Building X did not have any special corridor that was used as a means of escape when a fire happened. Only one corridor was used for daily activities in the building (see Figure 5). It also had a lot of furniture and objects such as waiting chairs. This condition downgraded the corridor's role as a means of egress.

Every door leading to the corridor in the building could fully swing into the room. However, a few doors could not be fully opened because they

were hindered by misplaced furniture or objects. The building only had two exit doors located on the first and second floor respectively. In contrast, there was no exit door on the third, fourth, and fifth floor. All exit doors swung inwards. This is not allowed because according to the Regulation of Minister of Public Works No. 26/PRT/M/2008, an exit door is allowed to swing inwards only if less than 50 people occupy the building and no highly hazardous materials are stored inside the building (Ministry of Public Works of Indonesia, 2008). Emergency lighting must be available in case of a blackout and it should be able to last for ten hours at a minimum. An electrical generator must be provided in the building as an alternative energy source.
