## Coral Reef Degradation Due to Ship Grounding in Indonesia: Case Study of Ship Aground in Bangka-Belitung Waters by Mother Vessel MV Lyric Poet

Idris<sup>1\*</sup>, Neviaty P. Zamani<sup>1\*</sup>

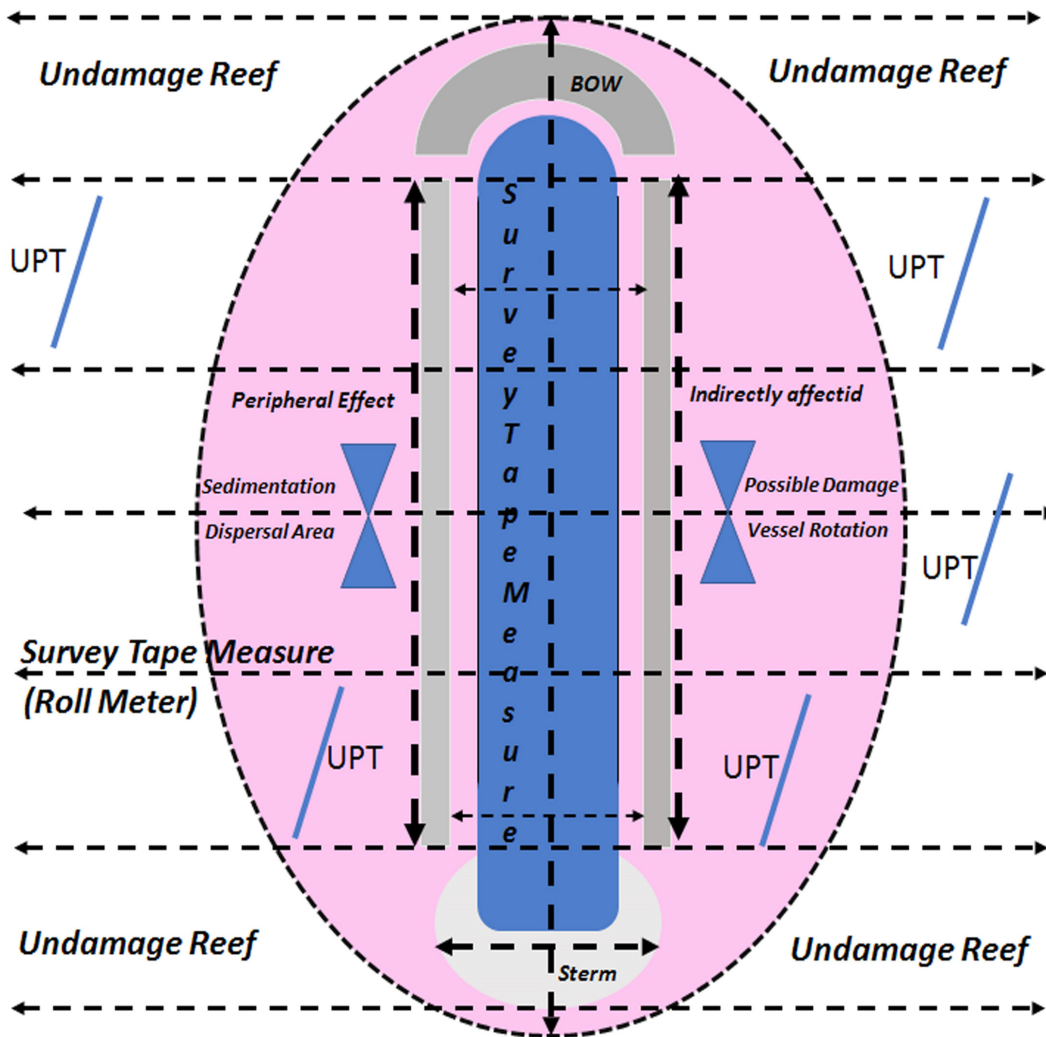
Figure 2. Fishbone method visualisation to measure damaged area.

Damaged area value was obtained through distance measurement between each point underwater. Values obtained were then calculated with the arbitrary polygon area equation:

$$A_p = \frac{(X_1 \cdot Y_2 - X_2 \cdot Y_1) + (X_2 \cdot Y_3 - X_3 \cdot Y_2) + (X_3 \cdot Y_4 - X_4 \cdot Y_3) + \dots + (X_n \cdot Y_1 - X_1 \cdot Y_n)}{2}$$

Data collection technique used travel survey; with transect line as a guide. *Swim survey* was done to execute quick observation by marking the scene and the geographical coordinates (Hill and Wilkinson, 2004). Ocean floor substrate data collection was done with *Underwater Photo Transect* (UPT) (Giyanto, 2012a; Giyanto, 2012b). Observation points were set on affected areas (three transects each). Variation data collection was carried out using belt transects and enumeration (English, *et al.*, 1997), 2 x 50 m each transect. Damaged area measurement was done through the Fishbone method (Figure 2) (Hudson and Goodwin, 2001; Collier, *et al.*, 2007).

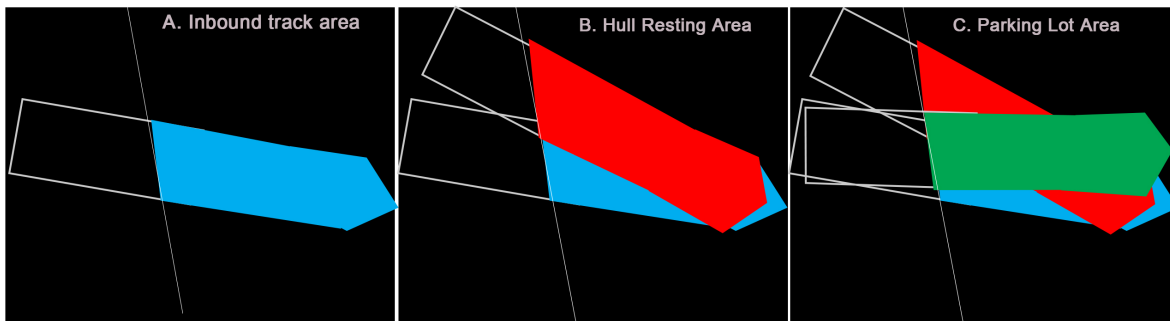
Figure 3. Model of grounding process A. Inbound track area, B. Hull Resting Area, C. Parking area

Area measurement of damaged coral reef zone was carried out using the ground truth approach and simulation of the grounding was made to obtain the visualization of the damage received. Processes of the ship's grounding up to the re-floating are usually modelled after the 3-step pattern (Tissier, 2010); first

step would be the ship's entry point and grounding with unparalleled bow and steer position, the second step is when the tail of the ship swings outwards (bright red), the last is when the hull is parallel in the rescue process, increasing the damaged area (bright green).

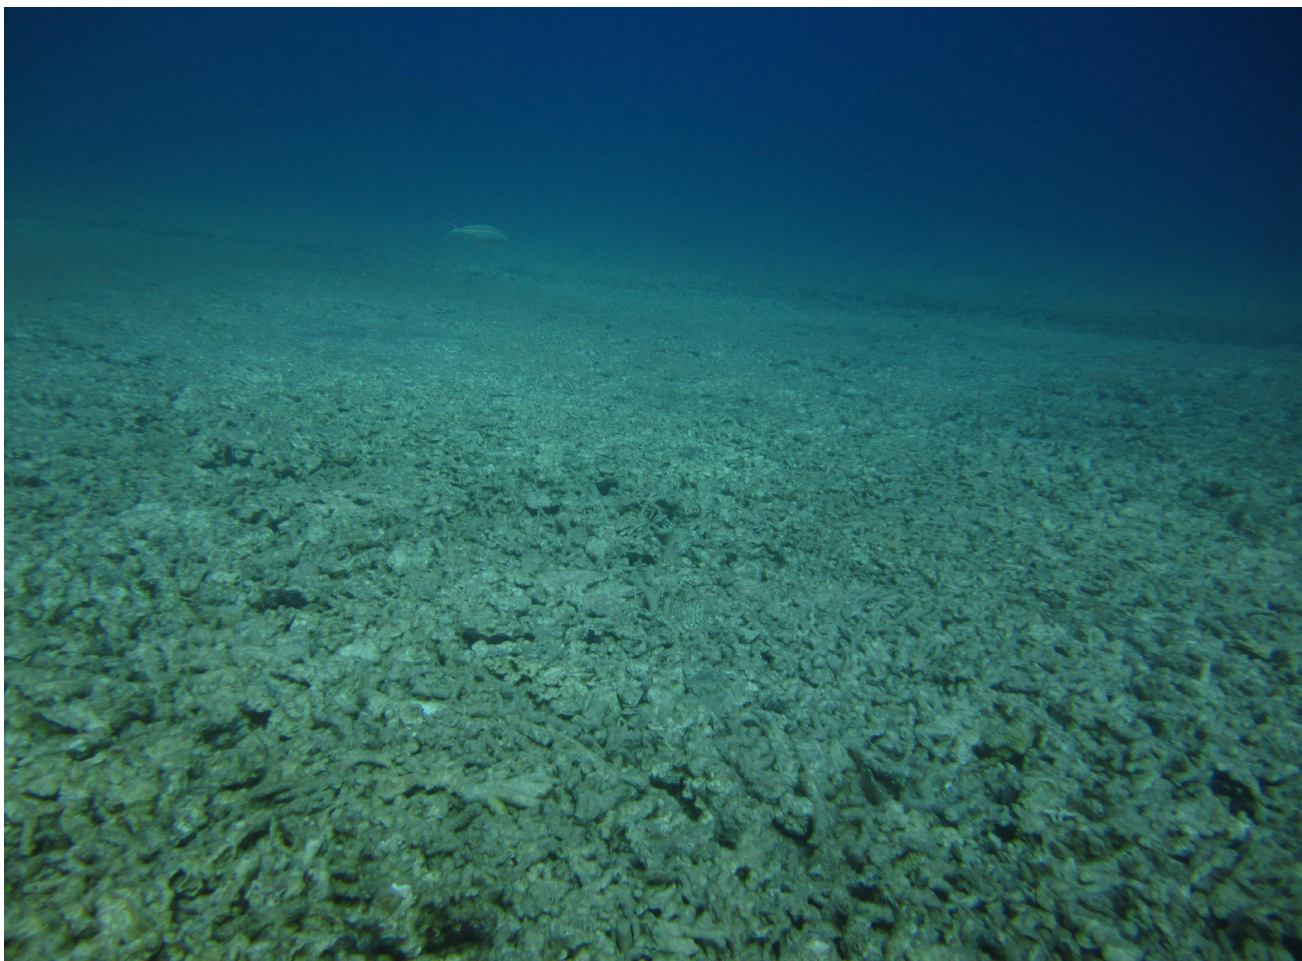
Figure 4. Coral reef condition on trajectory zone

- a. Trajectory zone (Figure 4) is the primary zone where the hull impacts the coral reef. The main characteristic was the ground and cut coral reef formation, first seen at 11 m depth to about 9 m depth. This made some kind of canal in the reef formation, leaving mostly rubbles and lumps or mounds of reef debris along the canal walls with average heights of about 3 m. There appears to be a colony of *Porites* sp. with diameter of 4 m, shifted quite far to the left, indicating heavy impact to the reef edge, between the trajectory zone and propeller zone. Reef biota seemed to have died off completely. A number of massive reefs had their top shattered and destroyed by the impact of the ship’s bow. This area had the most severe damage; creating unstable pile of reef debris. This reef debris is unsuitable for juvenile reef growth as it is unstable and may shift at any moment, also hindering its restoration capability. The natural recruitment of juvenile reefs on the reef debris is either terribly low or simply unsuitable for recruitment (Fox, et al., 2005; Raymundo, et al., 2007; Edwards and Gomez, 2008), the existence of strong currents or storms renders the natural fusion of coral reefs to be low and may eliminate nearby coral colonies (Bruckner and Bruckner, 2001).

Damaged area measurement was done using arbitrary polygon approach. Trajectory width average was 31 m, which matches with the ship’s width of 32.25 m. Trajectory length was 170 m on its left and 150 m for its right with average length of 160 m. mortal coral colonies, coral debris, and coral erosion sediment were in this zone. Total damage area in trajectory zone was 4,960 m<sup>2</sup>.

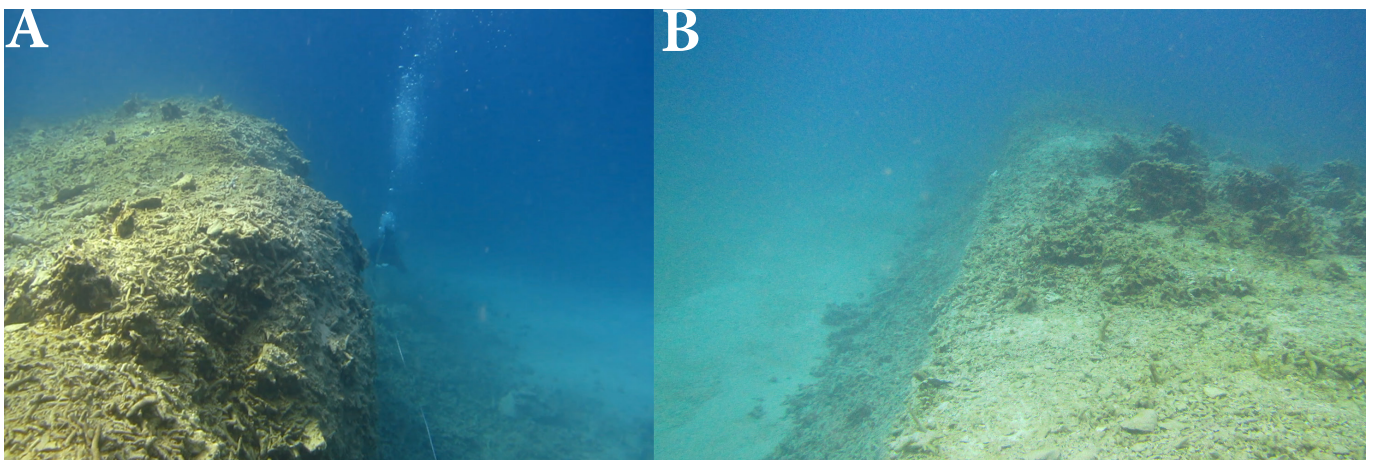
Figure 5. Coral reef condition on Mound zone (A=Left mound and B=right mound).

- b. Mound zone (Figure 5) was a pile of various coral debris and chalk structure shards mounted on the left and right of the canal walls with average mound height of 3 m and width of 5 m. Similar to the trajectory zone, the damage on coral reefs and benthic biota was severe and benthic lifeforms were not found in this area. Ocean floor substrate was dominated by coral shards and sand lifted by the ship’s hull. This type of physical damage is classified as acute and poses a significant threat to the coral reef and its restoration process (Lirman, et al., 2010; Raymundo, et al., 2018). Aside from that, flung coral fractures will also damage corals around it and proves to be a difficult substrate for juvenile coral growth (Idris et al., 2019). Measurement results of the mound zone acquired shows an average width of 5 m for each side, wall height measurement acquired was 2.5 m with length of 160 m. Total damage area for this zone was 1,600 m<sup>2</sup>.

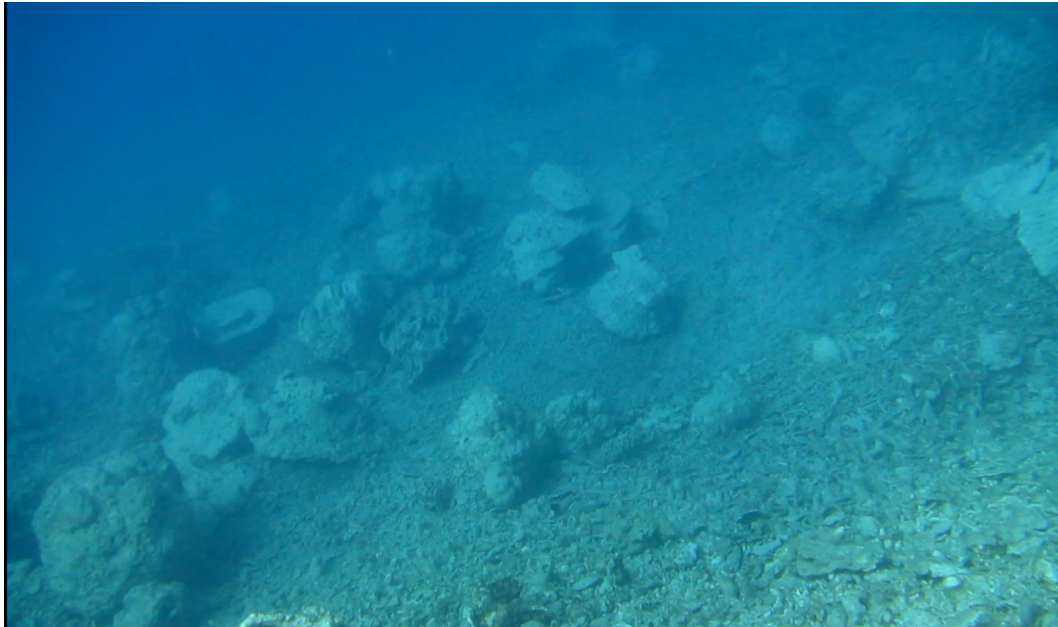
Figure 6. Coral reef condition in propeller zone

- c. Propeller zone (Figure 6) as a coral reef “plain” with depth of 14 m and 16 m, forming a con-cave shape, a ditch. Two ditches were likely to form due to the draught height (depth in this case) of 11.2 m, deep enough to dig 16 m down. Damage in this area was also severe, although the damage form differed from the former, being was in the form of split massive corals with size larger than that of rubble. Discerning characteristic of the damage was the coral colonies being ripped off and flung 20 m deep, causing it and another 98.5% of benthic biota to die. Observation results showed two attempts from the ship to dislodge from the parking area; once at the point of impact and once more at the rescue operation.

Those attempts managed to dislodge massive coral colonies with radius up to about 100 m. Some other research results have revealed that a sloppy rescue operation may cause further damage to other supposedly unaffected coral reef; causing acute effects that affects the regenerative process of coral biota (Aronson, 1997; Wakeford, *et al.*, 2008).

Damage area of this zone was an elongated concave ditch; urging the use of ellipse approach. Shortest diameter recorded for the first ditch was about 20 m and the longest was about 40 m. Shortest diameter recorded for the second ditch was about 50 m with the longest about 100 m. Estimated damage area was 3,140 m<sup>2</sup>.

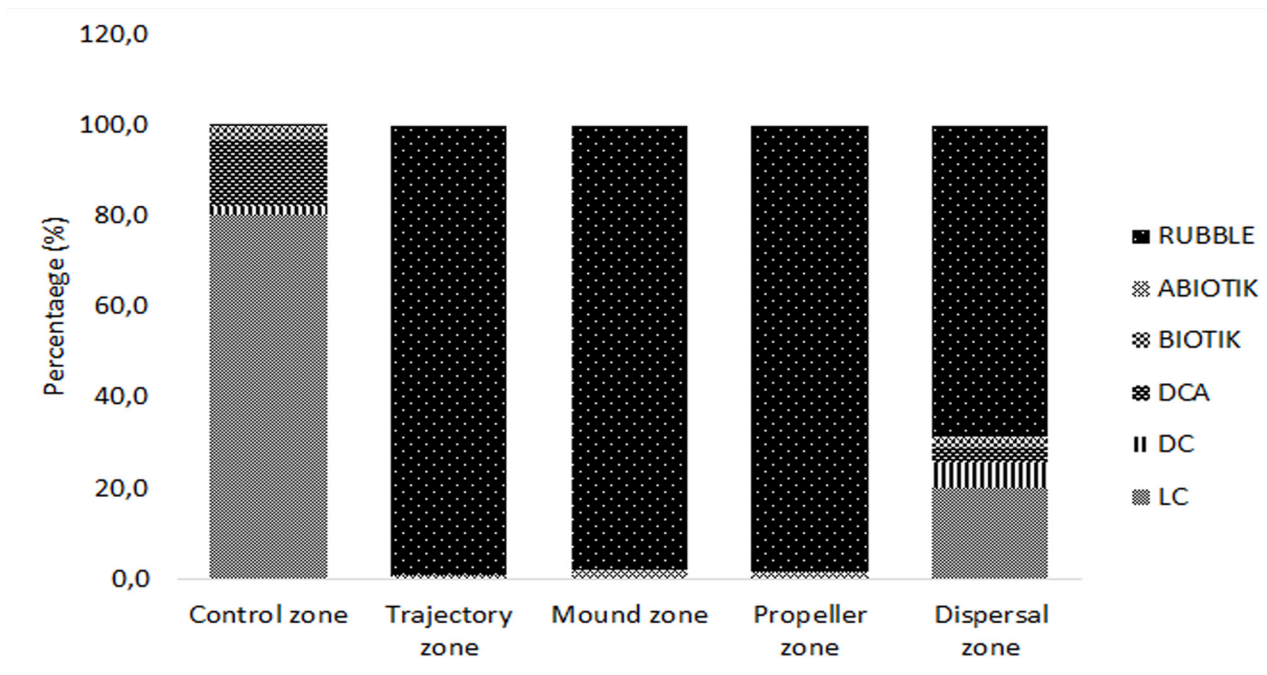
**Figure 8.** Percentage comparison graph of floor substrate coverage of control and affected area

Observation result of the substrate condition in the control zone found live coral coverage of 80.38%; classified as a very good condition; dead coral with algae coverage of 14% and rubbles 0.2%. Directly affected areas such as trajectory zone, propeller zone, and mound zone did not show any benthic lifeform, especially live hard corals, however it was dominated with rubble (99%, 98%, 98.5% for each zone, respectively) and sediment erosion such as chalk, mud, and fine sand (1%, 2%, and 1.5%). At the dispersion zone (indirectly affected), live hard coral coverage found was 20%; classified as damaged, with rubble coverage dominating (69%). Full data of ocean floor substrate coverage of every zone can be seen on [Figure 8](#).

High coverage of rubble on affected area, compared to control area, shows that the damage was massive. Degradation of live coral condition on the crash site was significant, as proven by single factor ANOVA analysis. It was shown that the coral death was significantly different, where  $F_c > F_{table}$  ( $F_{table} = 5.31$ ;  $F_c = 6.78$ ,  $p < 0.05$ ); meaning that the grounding of MV Lyric Poet vessel has caused a severe damage to coral reef, where live coral degradation reached 100%. According to a statement by [Riegl, \(2001\)](#) that sunken ship causes significant degradation of live coral coverage up to 58% and leaving behind coral debris that keeps increasing as long as there are no stabilizing attempts by benthic lifeforms. Increasing dominance of coral shards will happen because of the dispersion being dependent on the ocean dynamics; therefore it covers and kills off remaining benthic biota in the vicinity. According to [Yusuf, \(2014\)](#) all corals in affected area will be ground clean (95% dead corals and 5% sand will be left), leaving small, unstable pieces and shards (< 25 cm) that are easily swept away by the current.
