Case Report

Management of white spot and central diastema on anterior teeth with direct composites restoration (a case report)

Adioro Soetojo and Bintang Adiguna Widjaja

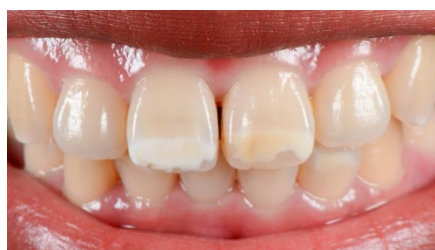
Figure 1. Preoperative look: White spot on tooth 11 and 21 and central diastema.

A 22 years old woman came to Airlangga Dental Hospital with a chief complaint of shyness and lack of confidence due to some white spot and gap on the two central front teeth. The patient's medical history did not reveal any systemic diseases. The clinical examination showed white spot lesions on tooth 11 21 and central diastema between 11 21 (Figures 1). All anterior teeth, as well as the surrounding soft tissues were immaculate and healthy. The decision was made to improve his smile with a conservative, direct adhesive procedure using resin composite.

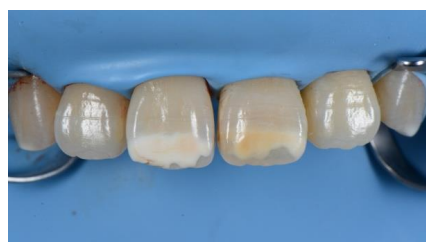
Figure 2. Rubber dam placement to achieve an asepsis area.

All of the treatment were done in one visit, anamnesis, clinical examination, thorough explanation, and initial study to understand about patient's consent in esthetic treatment procedure were done. First, rubber dam was placed to achieve an asepsis area. Blue color sheet was chosen in order to give a contrast color to make it easier in choosing color and doing the multi-layering technique (Figure 2).

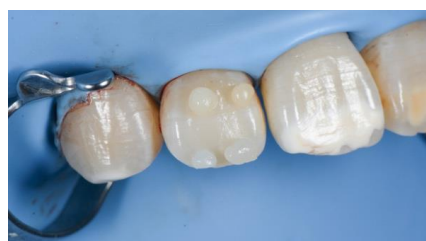
Figure 3. Composite shades taking.

After rubber dam was placed, composite shades taking was done by using button shade technique. It was done on lateral incisor. Mass of dentin color was placed on cervical area and mass of enamel color was placed on incisal area then light cured. Micerium UD3 color was chosen for dentin shade and micerium UE2 was chosen for enamel shade (Figure 3). Minimal invasive preparation was done to remove all of the white spot. Beveling was done to give a better retention of composites and to help blending the color better at the border between the real tooth and the restoration (Figure 4).

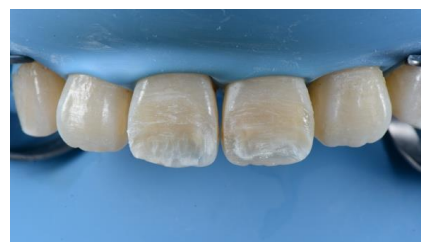
Figure 4. Preparation of the teeth

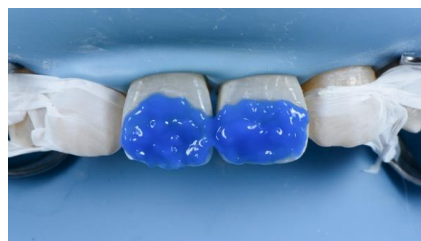
Figure 5. Total etch procedure

Teflon tape was placed at the lateral incisive to protect lateral teeth from the etch. Total etch technique was done by using 37% phosphoric acid for 30s on enamel and 15s on dentin, then rinsed with water spray and dried (Figure 5).

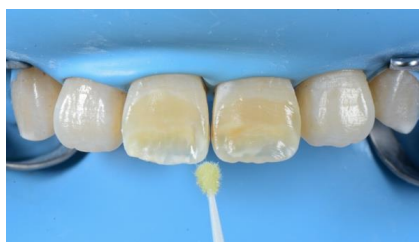
Figure 6. Bonding procedure

Thin layer of prime&bond® one ETCH & RINSE was applied with rubbing motion on the surface and then dried with compressed air until there was no movement from the bonding and then light cured (Figure 6). Dentin part was layered using UD3 Micerium dentin color. Mamelon was made and then light cured (Figure 7).

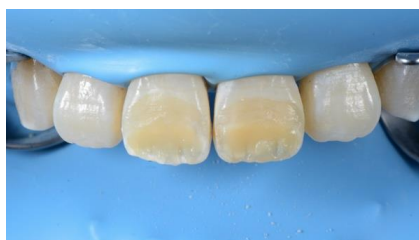
Figure 7. Dentin layering

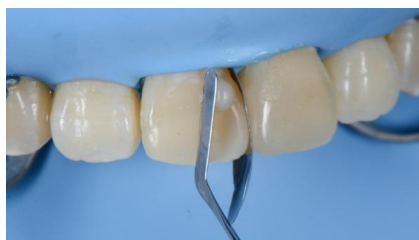
Figure 8. Enamel layering

Final layering for enamel and diastema closure were done using Micerium UE2 Enamel color then light cured. Sectional matrix were placed vertically to make the proximal contour of the restorations (Figure 8). The finishing was done using abrasive disc and lastly, the restorations were then polished with lowspeed handpiece and Enhance® PoGo® systems (Figure 9 and 10).

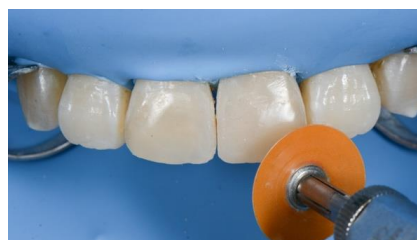
Figure 9. Finishing and polishing

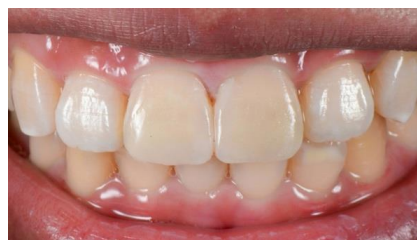
Figure 10. Final result, the restoration color managed to blend naturally and the central diastema already closed.
