Implementation of Installation and Maintenance Portable Fire Extinguisher in Circuit Breaker Manufacture

Penerapan Pemasangan dan Pemeliharaan Alat Pemadam Api Ringan di Industri Saklar Elektrik

Herdy Perdana Wicaksono

PT Kamadjaja Logistik Surabaya

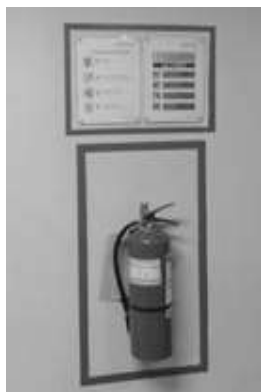
to carried out the maintenance, inspection and recording. The inventory number is in the form of a label with numbers written on the APAR tube. This can be seen in the figure 1.

Figure 1. The Used of Numbering at PT Y Indonesia in 2016
