Case Report

Anterior makeover on fractured teeth by simple composite resin restoration

Eric Priyo Prasetyo

Department of Conservative Dentistry
Faculty of Dentistry, Airlangga University
Surabaya-Indonesia

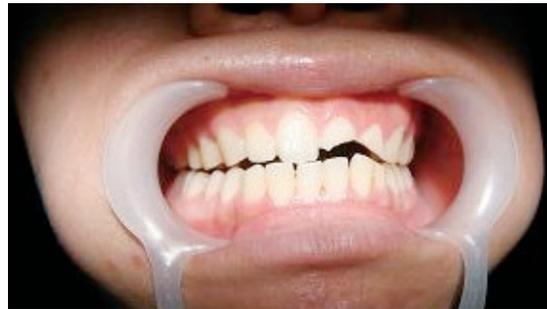
A 19 year old female patient came with fractured teeth on 21 and 22 (Figure 1). This patient is an undergraduate student and starts to feel less confident with her fractured teeth since entering college. On anamnesis, the patient had a previous history of dental trauma about nine years ago and was brought to a local dentist for debridement and was given analgesic, the involved teeth were not given any treatment because based on the radiographic image, the apical were still in development and not constricted yet. The teeth were controlled by the previous dentist and no symptom was

Teeth 21 and 22 were fractured almost half cervico-incisally. These teeth were responsive to thermal and supported by healthy gingiva. There was no abnormal tooth movement. There were no pulp exposures on each tooth. After thorough explanations, the patient approved and consented about the single visit anterior makeover procedure by simple composite resin restoration. The restoration planning was determined using microhybrid composite and total etch technique.

Figure 1. Pre-makeover anterior teeth condition.

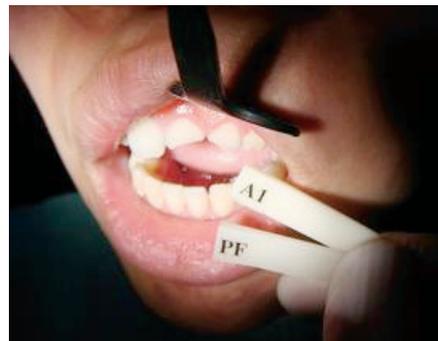
Figure 2. Shade selection was carried out to restore the teeth.

After anamnesis, clinical examination, thorough explanation, and patient's consent about the makeover procedure, the involved teeth was cleaned and brushed with prophylaxis scrub (Consepsis Scrub, Ultradent) and made ready for shade selection. Shade selection was carried out on damp teeth with the provided composite shade guide from the manufacturer and shade A1 and PF were chosen for both teeth (Figure 2).

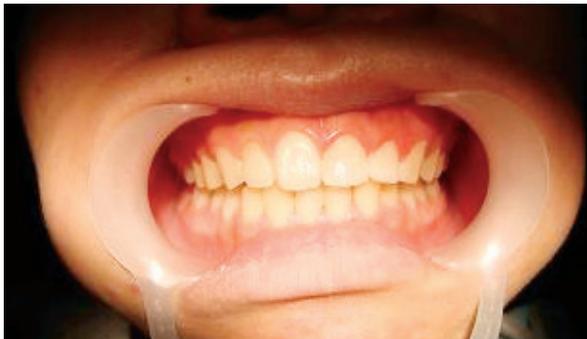
Figure 3. Teeth condition after anterior makeover.

The restorations were then contoured and the excess composite resin was removed using fine finishing diamond bur (Sharpcut, Dentsply) and polished with diamond micro polisher (Pogo, Dentsply). The makeover showed better teeth hence changed the appearance and restore patient's self confidence (Figure 3). Patient follow up was done six months after treatment, there were no complaint, the composite restorations were still in good condition and the patient was happily satisfied with the result. The patient came for regular dental check up about two years later and the restorations were still in good condition and functional (Figure 4).

One step diamond micro polisher was used for several reasons; practical and capable to produce acceptable gloss finish on microhybrid composite restorations.¹⁴ Even though the cervical gingival lining in 21 was not equal to 11 (Figure 3), it was considerably accepted by the patient, realizing that the lip line could hardly reveal the cervical gingival lining when smiling (Figure 4). However, the patient was explained about gingivoplasty as an optional procedure. Patient's cooperation is mandatory in retaining dental makeover result, this include the awareness to maintain basic oral health and daily hygiene. Regular visit to dentist is also important to notice any changes on patient's overall teeth condition which support the longevity of the established restoration.

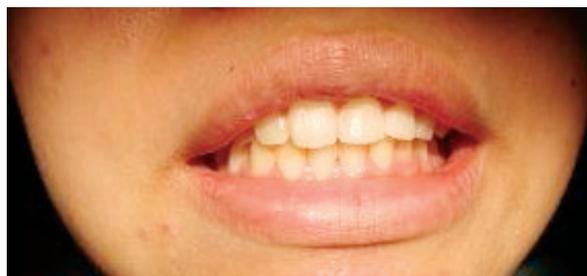
Figure 4. Teeth condition on follow up (two years after makeover).
